THE SHELL PETROLEUM DEVELOPMENT COMPANY OF NIGERIA LIMITED.

JOINT INVESTIGATION REPORT FOR INCIDENT NO: 1200680 JIV report S/N: 0533

1. Spill incident Number: 1200680 2. Type of incident\* OIL SPILL  
3. Name of Location 28<sup>th</sup> BOMU - BONNY TRANS NIGER PIPELINE  
4. Name of nearest community OWOKIRI 5. State: RIVERS 6. LGA ANDONI  
7. Type of Production facility/Installation OIL PIPELINE 8. Asset owner/District PIPELINE/SWAMP

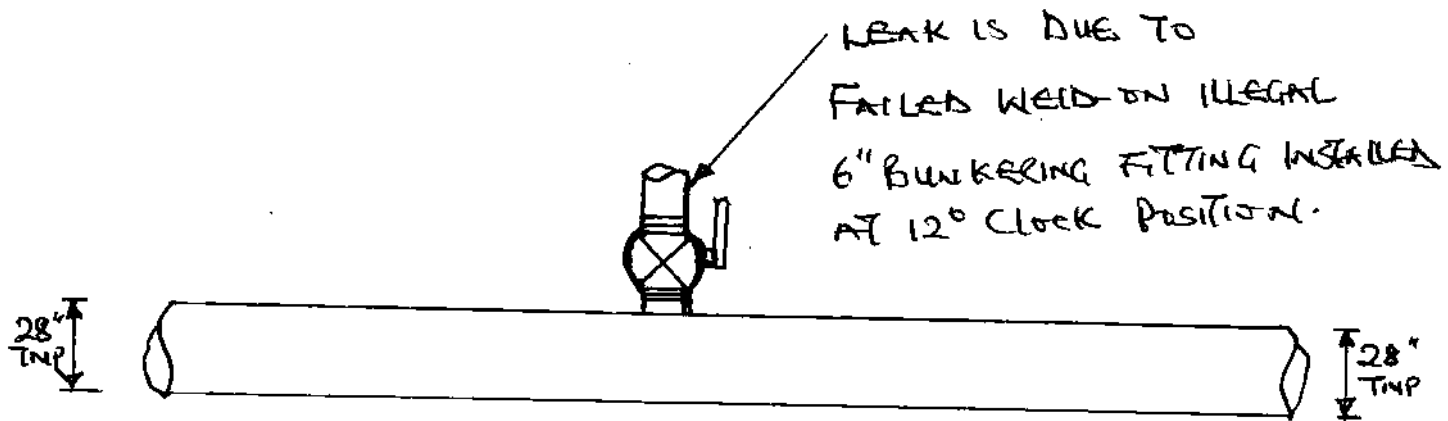
| <input checked="" type="checkbox"/> Failed Weld-on illegal hot tap valve, | <input type="checkbox"/> Failed Clamp | <input type="checkbox"/> Missing Pipeline/Flowline |
| <input checked="" type="checkbox"/> Crude oil theft (illegal bunkering) point, | | <input type="checkbox"/> Third party tampering with Clamp |

SECTIONAL VIEW OF 28" BOMU - BONNEY TRANS NIGER PIPELINE

AT OWOKIRI SHOW FAILED WELD ON ILLEGAL HOT VANE.

If yes to item 14, give brief description: REPAIR DONE BY CLAMPING AND REMOVAL OF THE BUNKERING FITTING.
