# JOINT INVESTIGATION REPORT

INCIDENT NO: 2676105 JIV report S/N: 0550

1. Fountain Incident Number: 2676105 2. Type of incident\* OIL SPILL  
3. Name of Location 14" OKORDIA - RUMMERKE PIPELINE  
4. Name of nearest community ULA-DKOB0 5. State: RIVERS 6. LGA ATTOADA West  
7. Production Facility/Installation OIL PIPELINE  
8. Asset Owner/Hub THE SHELL PETROLEUM DEVELOPMENT COMPANY  
OF NIGERIA LIMITED / PIPELINE

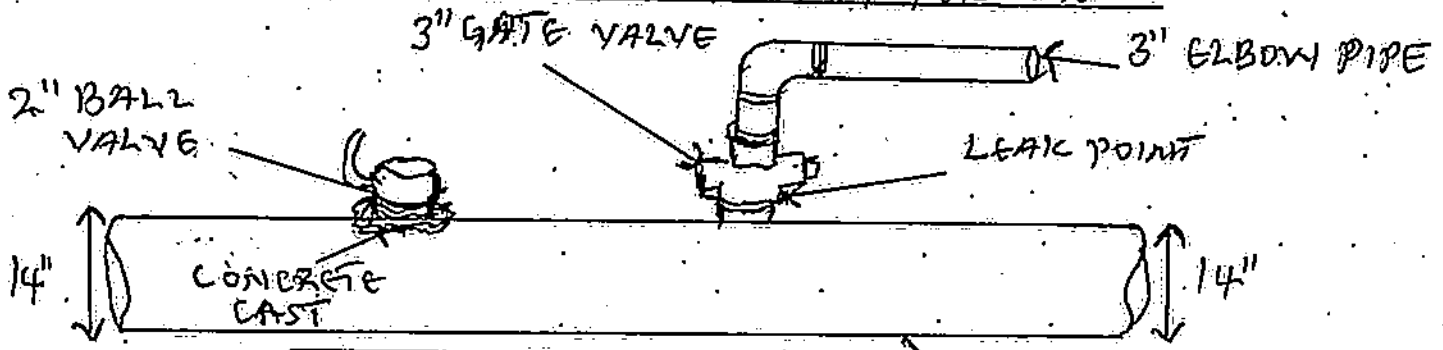
E. GRAPHIC DESCRIPTION OF LEAK POINT (while detailed description of the leak point should be contained in the leak report, overview sketch of the site should be added as appendix 1)

SECTION OF 14" OKORDIA - RUNGUEPE PIPELINE AT ULA-OKOBO SHOWING TWO NOS OF CRUDE OIL THEFT POINTS INSTALLED AT 12 O'CLOCK POSITION BY UNKNOWN PERSONS.

FROM OKORDIA TO RUNGUEPE
