THE SHELL PETROLEUM DEVELOPMENT COMPANY OF NIGERIA LIMITED.

JOINT INVESTIGATION REPORT FOR INCIDENT NO: 937909 JIV report S/N: 0023

1. Spill incident Number: 937909 2. Type of incident* OIL SPILL
 3. Name of Location 18" ASSA - RUMUKEPE PIPELINE
 4. Name of nearest community AWARA 5. State: IMO 6. LGA OHAJI / EGBEMIA
 7. Type of Production facility/Installation OIL PIPELINE 8. Asset owner/District NPE / EGBEMIA

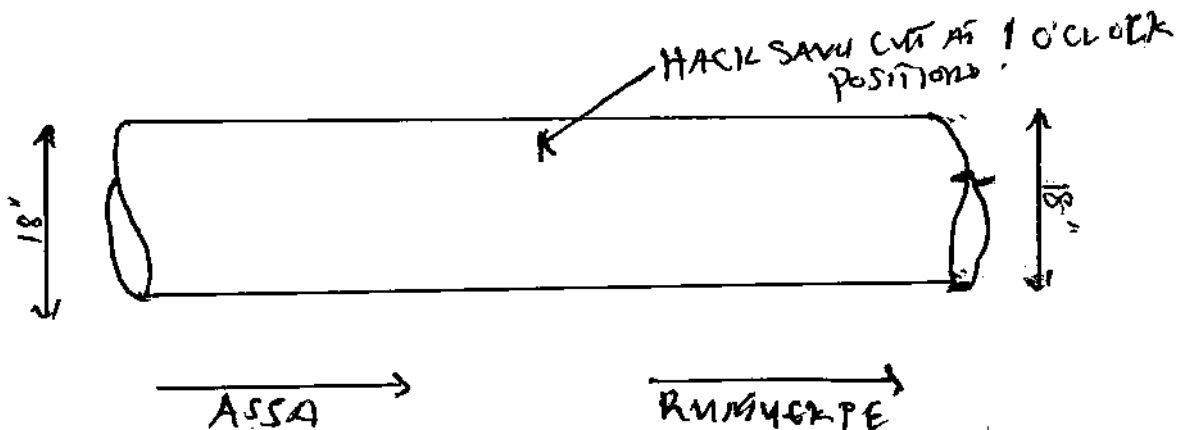
e. Description of leak point (tick as applicable);
 Drilled hole Hack saw cut Tear (_____),
 Complete Rupture Inward dent, Well head tampering
 Failed Weld-on illegal hot tap valve, Failed Clamp Missing Pipeline/Flowline
 Crude oil theft (illegal bunkering) point, Third party tampering with Clamp
 Third party tampering with valve setting, Third party tampering with flange,
 Corrosion Saver-pit over flow, Surge vessel overflow,
 Bulging Outward Flare System/Bund wall failure Accidental 3rd party equipment
 impact Valve Failure com unit failure Cold vent
 Relief valve failure Others (specify) _____

- Third party interference (Sabotage ; crude theft ; Line theft ; Accidental 3rd party damage
 Operational Others (including Mystery spills) _____

SECTION OF 18" ASSA - RUMUKEPE PIPELINE AT AWARA
SHOWING POSITION OF HACK SAW CUT AT 1 O'CLOCK POSITION.

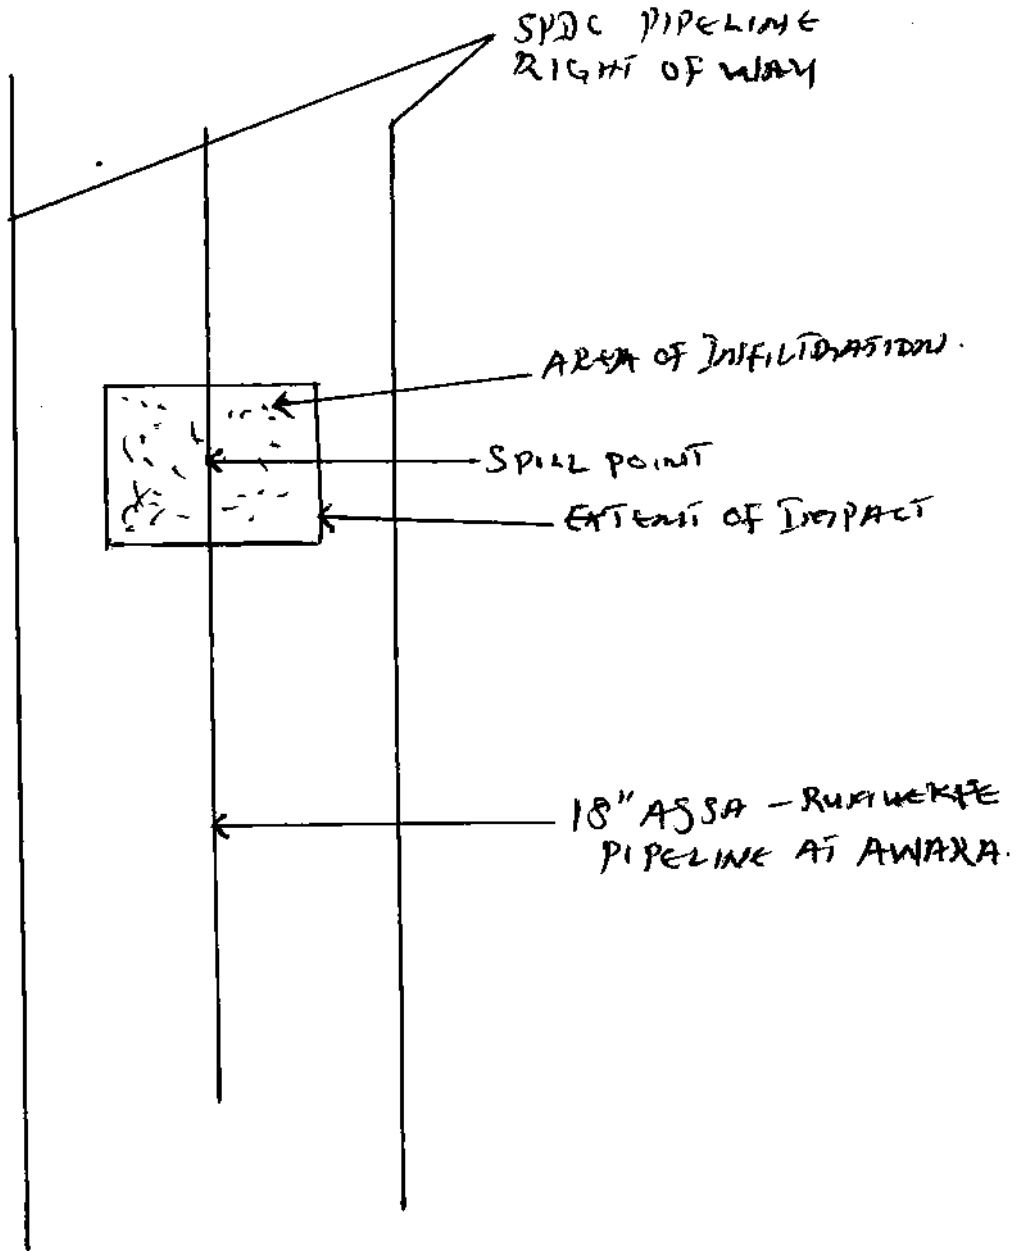
28. Appendix 1: Overview sketch of the site

Location: 18" ASSA - RUMUWERE PIPELINE AT AWARA.
