THE SHELL PETROLEUM DEVELOPMENT COMPANY OF NIGERIA LIMITED.

JOINT INVESTIGATION REPORT FOR INCIDENT NO: 942987 JIV report S/N: 0035

1. Spill incident Number: 942987 2. Type of incident\* OIL SPILL  
 3. Name of Location 36" NKPOKU-BOMU PIPELINE  
 4. Name of nearest community AGBONCHIA 5. State: RIVERS 6. LGA ELEME  
 7. Type of Production facility/Installation OIL PIPELINE 8. Asset owner/District NPE/P#2

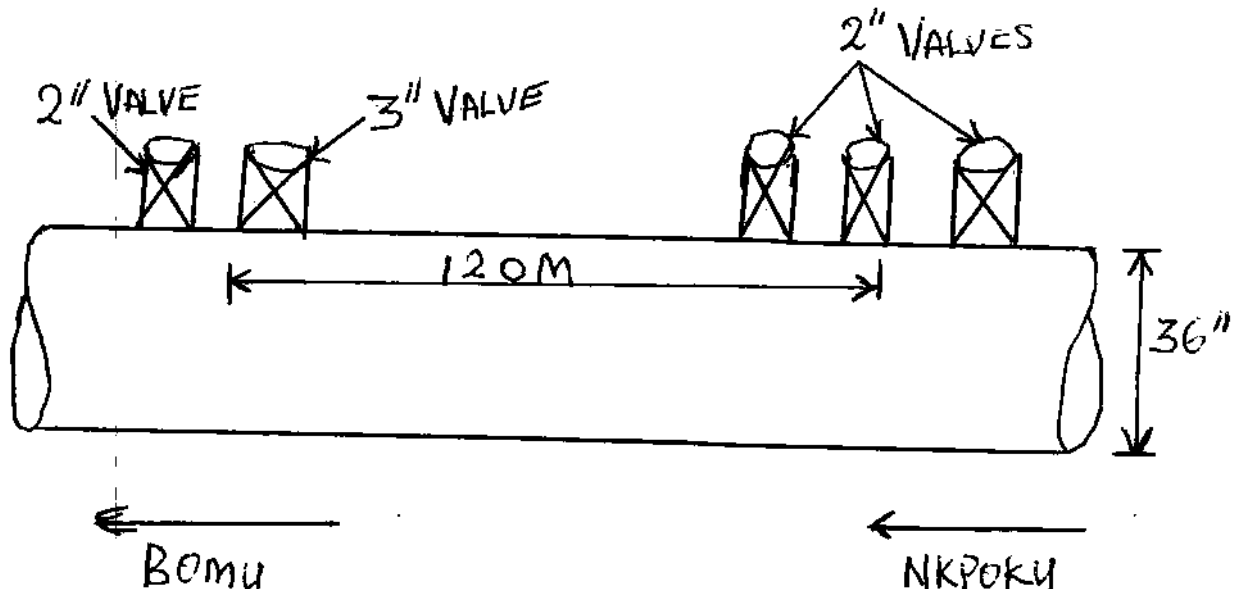
SECTION OF 36" NKPOKU-BOMU PIPELINE AT AGBONCHIA

NOTE: THREE CRUDE OIL THEFT POINTS WERE FOUND WITHIN THE LOCATION. TWO HAVE BEEN REPAIRED. THE THIRD POINT WHICH IS NON-LEAKING IS YET TO BE REPAIRED.

**E. GRAPHIC DESCRIPTION OF LEAK POINT** (while detail report of the leak point should be contained in the leak report, overview sketch of the site should be added as an appendix 1)
