THE SHELL PETROLEUM DEVELOPMENT COMPANY OF NIGERIA LIMITED.

JOINT INVESTIGATION REPORT FOR INCIDENT NO: 950831 JIV report S/N: 0042

1. Spill incident Number: 950831 2. Type of incident* GIL SPILL
 3. Name of Location 24" NEMBE CREEK TRUNKLINE (NCTL) PIPELINE
 4. Name of nearest community ABEREDO-A OWUANGAI 5. State: RIVERS 6. LGA AKUKU-TORU
 7. Type of Production facility/Installation PIPELINE 8. Asset owner/District NESP / SWAMP

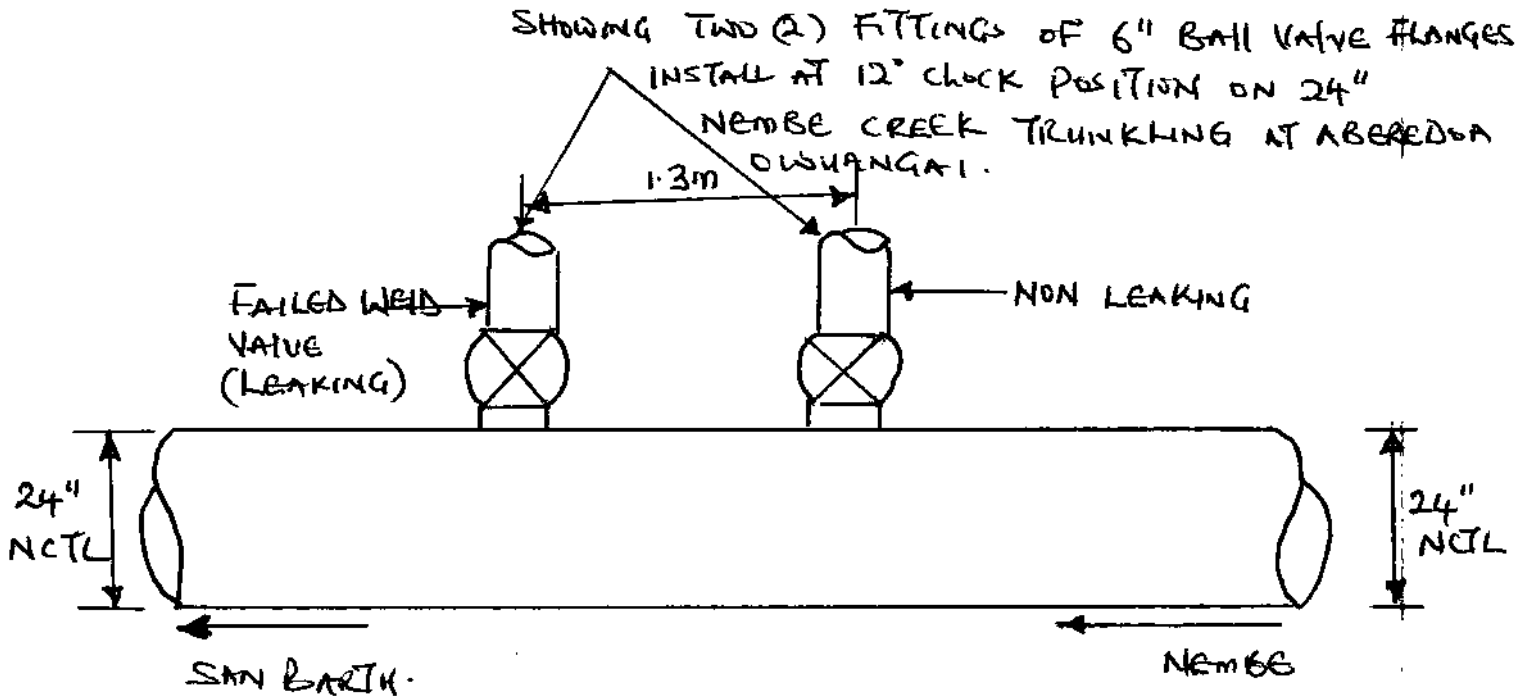
E. GRAPHIC DESCRIPTION OF LEAK POINT (while detail report of the leak point should be contained in the leak report, overview sketch of the site should be added as an appendix 1)

| <input checked="" type="checkbox"/> Failed Weld-on illegal hot tap valve, | <input type="checkbox"/> Failed Clamp | <input type="checkbox"/> Missing Pipeline/Flowline |
| <input checked="" type="checkbox"/> Crude oil theft (illegal bunkering) point, | | <input type="checkbox"/> Third party tampering with Clamp |

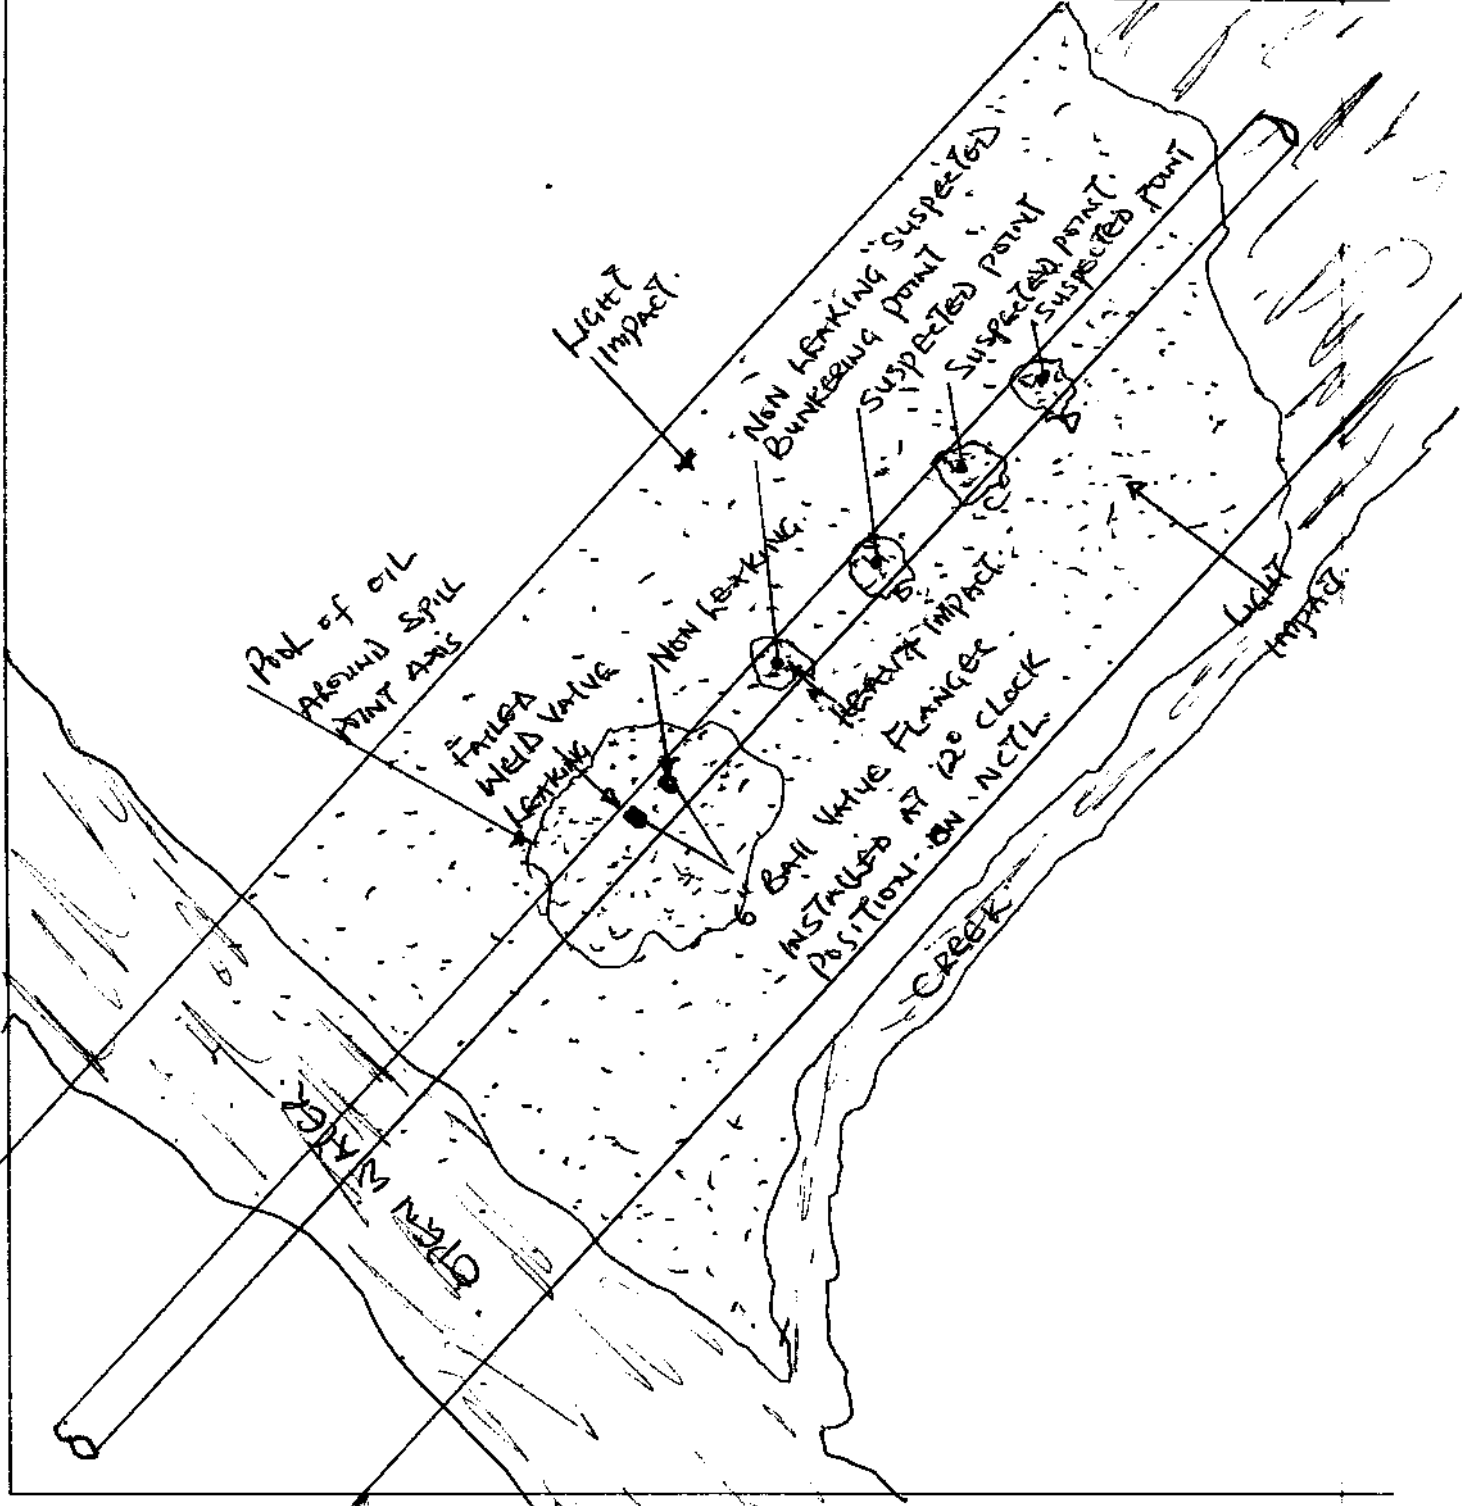
28. Appendix 1: Overview sketch of the site

Location: 24" NEMBE CREEK TRUNKLINE (NCTL) PIPELINE AT ARESO-A OBUANG
