THE SHELL PETROLEUM DEVELOPMENT COMPANY OF NIGERIA LIMITED

JOINT INVESTIGATION REPORT FOR INCIDENT NO: 0242 815388

1. Spill incident Number: 815388 2. Type of incident * OIL SPILL
 3. Name of Location IMO RIVER 1, WELL 26 2 FLOWLINE
 4. Name of nearest community OWAZA 5. State: ABIA 6. LGA UKWA-WEST
 7. Type of Production facility/Installation OIL FLOWLINE 8. Asset owner/ District PH2

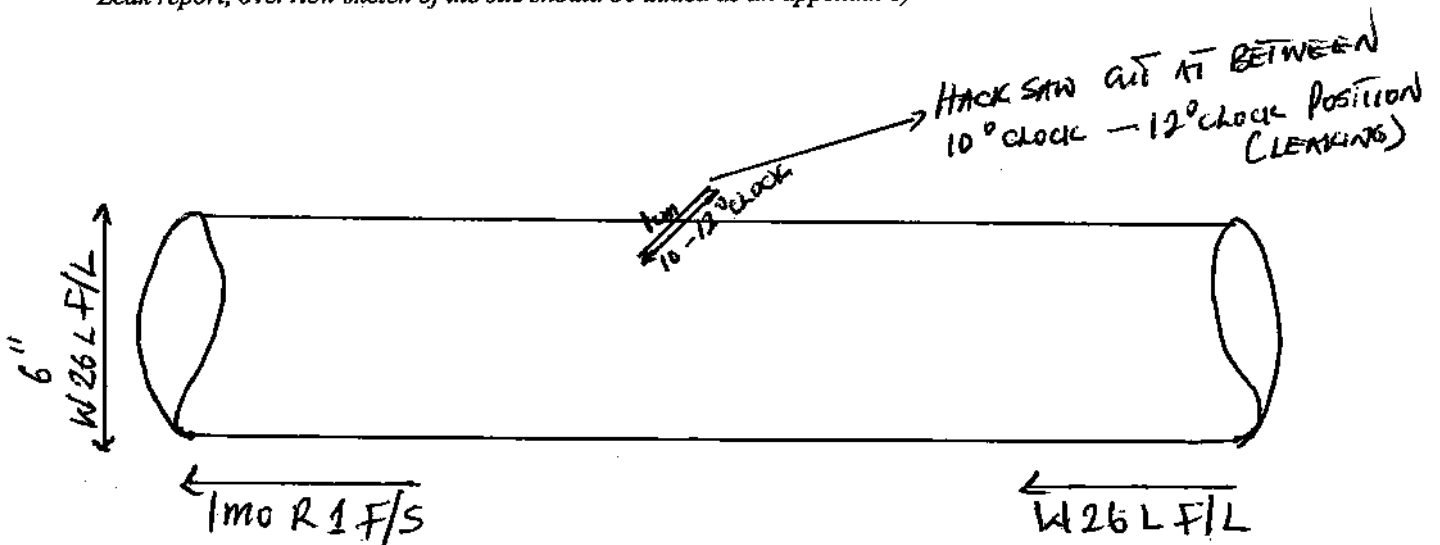
SECTION OF 6" IMO RIVER 1, W 26 LIMA FLOW LINE AT OWAZA, SHOWING LOCATION OF HACKSAW CUT AT 10-12° CLOCK POSITIONS.
