THE SHELL PETROLEUM DEVELOPMENT COMPANY OF NIGERIA LIMITED.

JOINT INVESTIGATION REPORT FOR INCIDENT NO: 984150 JIV report S/N: 0111

1. Spill incident Number: 984150 2. Type of incident* OIL SPILL
 3. Name of Location 24" BOMU - BONNY TRANS NIGER PIPELINE
 4. Name of nearest community BODO WEST 5. State: RNERS 6. LGA GOKANA
 7. Type of Production facility/Installation OIL PIPELINE 8. Asset owner/District PIPELINE/SWAMP

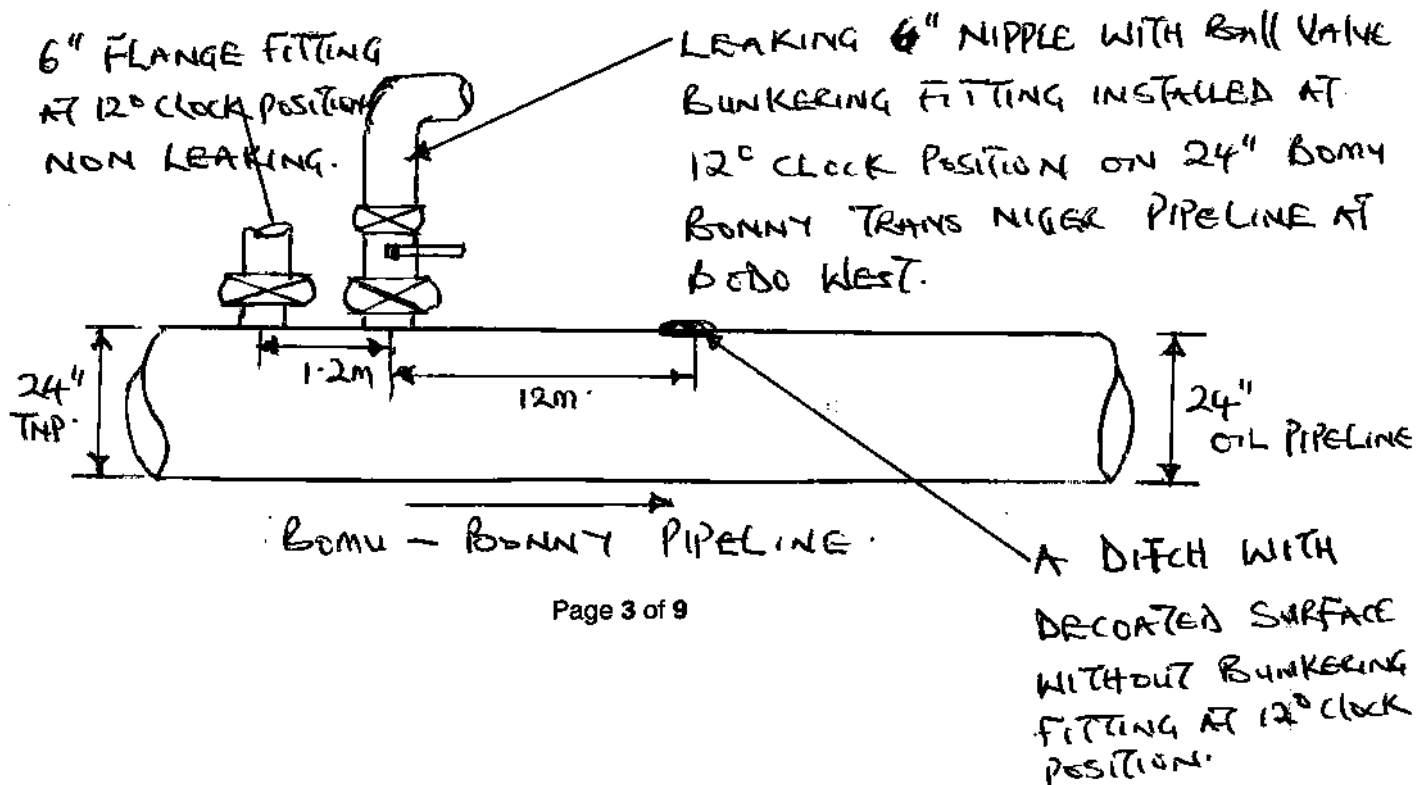
e. Description of leak point (tick as applicable);
 Drilled hole Hack saw cut Tear (_____),
 Complete Rupture Inward dent, Well head tampering
 Failed Weld-on illegal hot tap valve, Failed Clamp Missing Pipeline/Flowline
 Crude oil theft (illegal bunkering) point, Third party tampering with Clamp
 Third party tampering with valve setting, Third party tampering with flange,
 Corrosion Saver-pit over flow, Surge vessel overflow,
 Bulging Outward Flare System/Bund wall failure Accidental 3rd party equipment
 impact Valve Failure com unit failure Cold vent
 Relief valve failure Others (specify) _____

- f. Incident caused by:
 Third party interference (Sabotage; crude theft; Line theft; Accidental 3rd party damage
 Operational Others (including Mystery spills) _____

SECTIONAL VIEW OF 24" BOMU - BONNY TRANS NIGER PIPELINE
SHOWING 6" BUNKERING FITTING

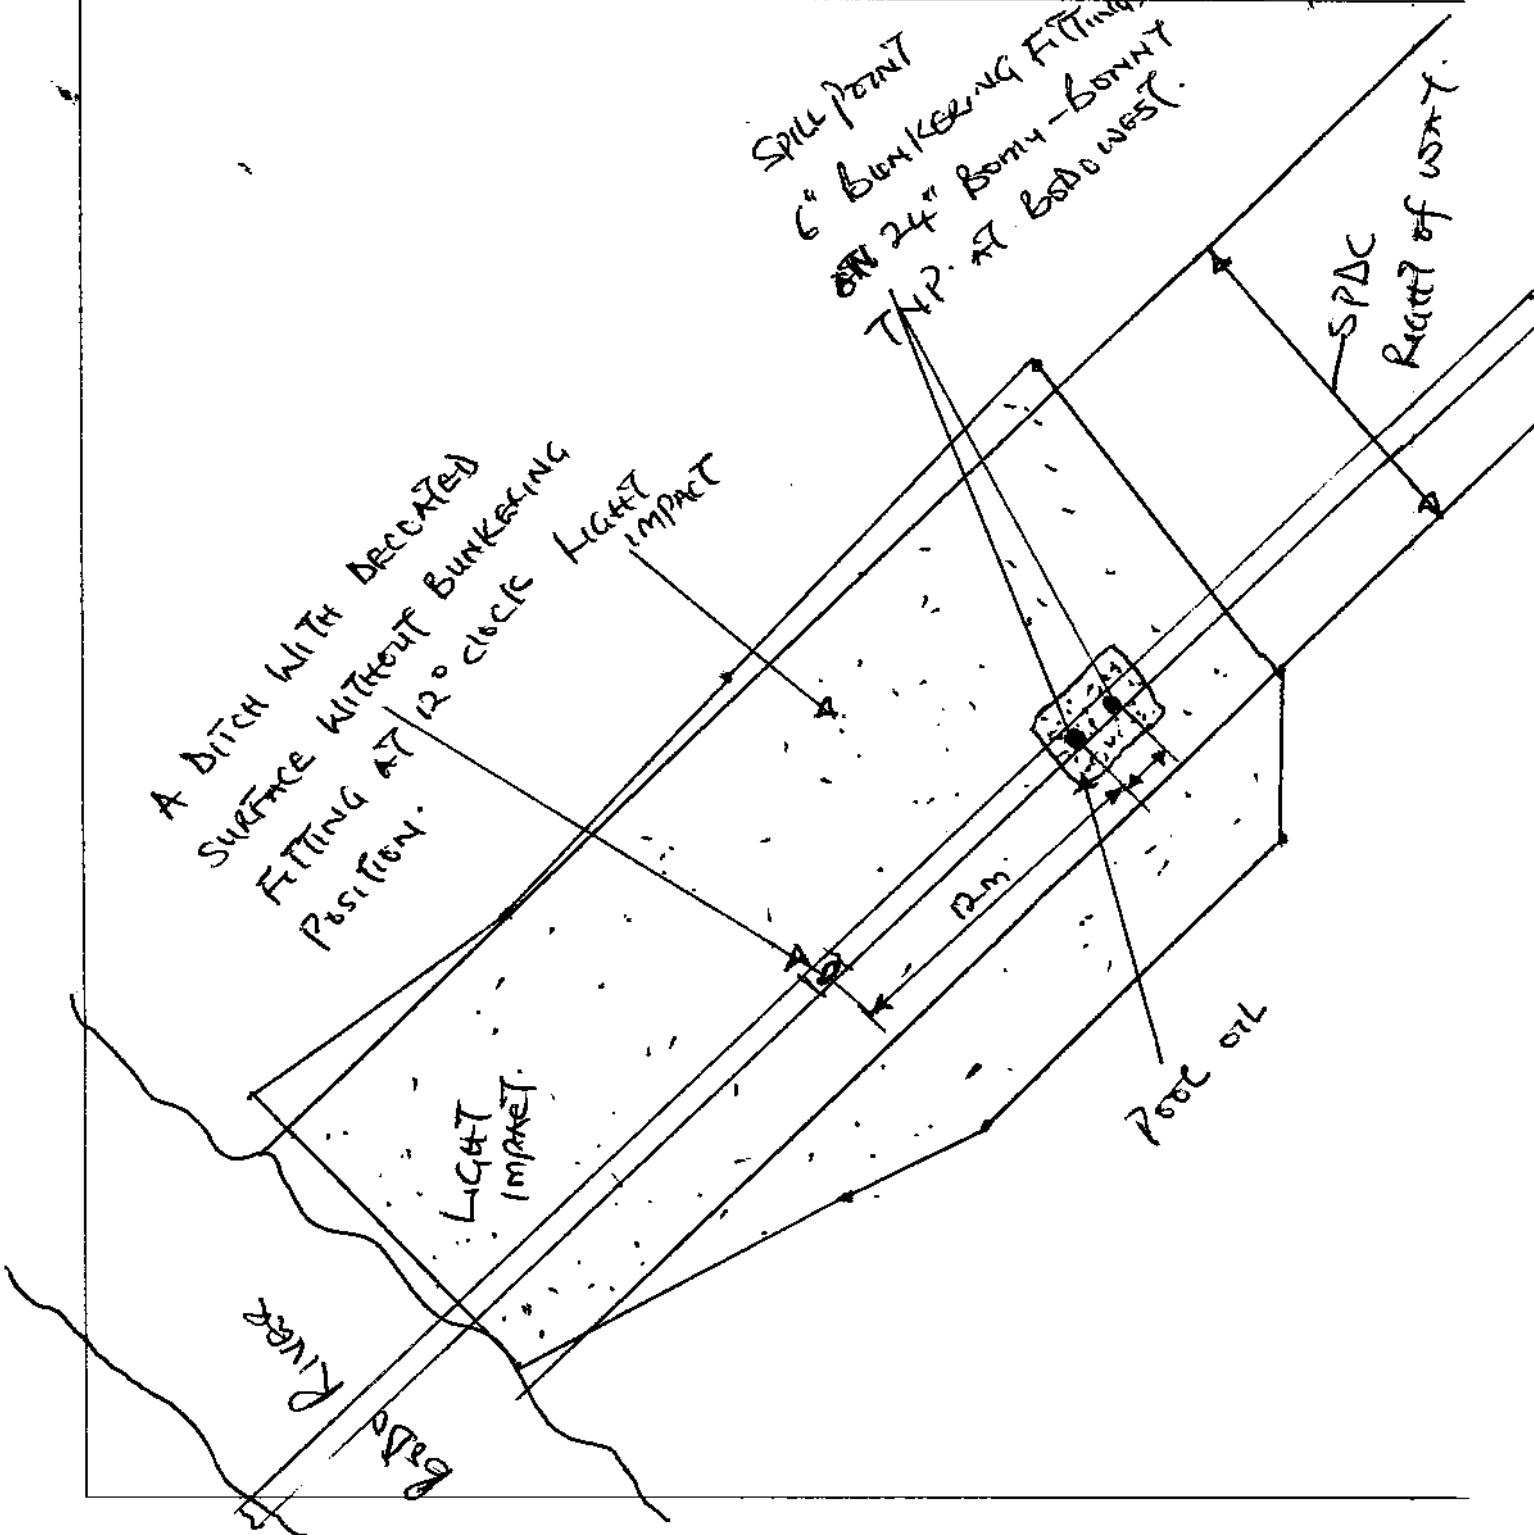
28. Appendix 1: Overview sketch of the site

Location: 24" BOMU - BONNY TRANS NIGER PIPELINE AT BODO WEST.
