THE SHELL PETROLEUM DEVELOPMENT COMPANY OF NIGERIA LIMITED
 JOINT INVESTIGATION REPORT FOR INCIDENT NO: 980991 JIV report S/N: 0107

1. Spill incident Number: 980991 2. Type of incident* OIL SPILL
 3. Name of Location 24" NKPOKU - BOMU PIPELINE
 4. Name of nearest community EGBALOR 5. State: RIVERS 6. LGA ELEME
 7. Type of Production facility/Installation OIL PIPELINE 8. Asset owner/District PIPELINE EAST

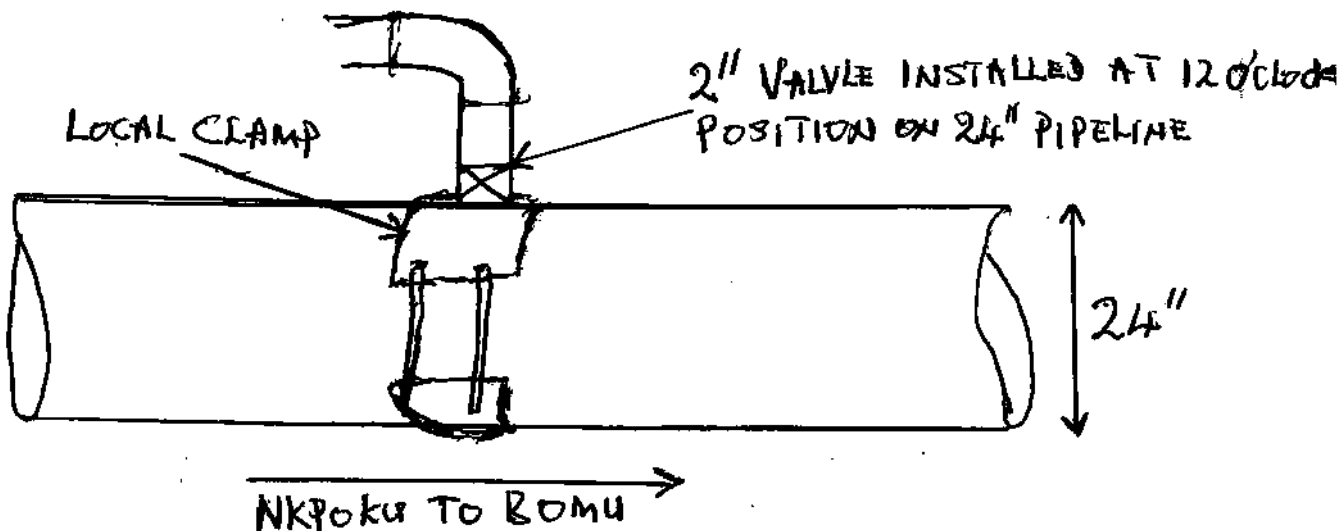
E. GRAPHIC DESCRIPTION OF LEAK POINT (while detail report of the leak point should be contained in the leak report, overview sketch of the site should be added as an appendix 1)

A SECTION OF 24" NKPOKU-BOMU PIPELINE AT EGBMLDR
SHOWING ILLEGAL BUNKERING POINT INSTALLED AT 12 O'CLOCK POSITION
