**THE SHELL PETROLEUM DEVELOPMENT COMPANY OF NIGERIA LIMITED.**

JOINT INVESTIGATION REPORT FOR INCIDENT NO: 1067829 JIV report S/N: 0340

1. Spill incident Number: 1067829 2. Type of incident\* OIL SPILL AND FIRE  
 3. Name of Location 201 BOMU - BONNY PIPELINE  
 4. Name of nearest community KPOR/K-DELE 5. State: RIVERS 6. LGA BOCKANA  
 7. Type of Production facility/Installation OIL PIPELINE 8. Asset owner/District PIPELINE

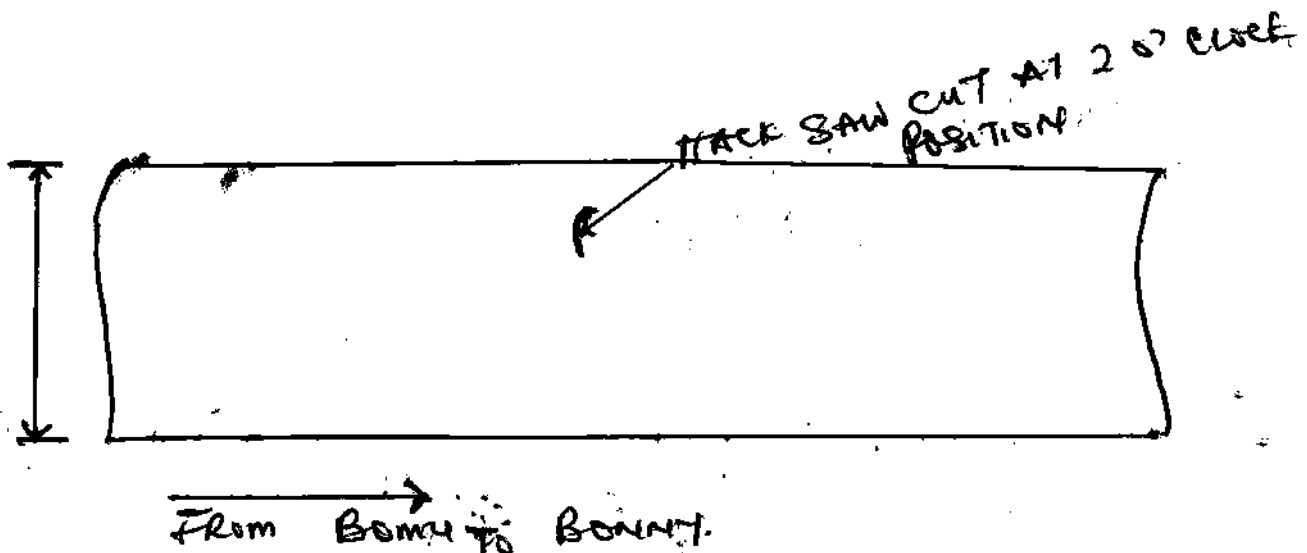
| <input type="checkbox"/> Drilled hole | <input checked="" type="checkbox"/> Hack saw cut | <input type="checkbox"/> Tear (_____). |

- Third party interference (Sabotage , crude theft ; Line theft ; Accidental 3<sup>rd</sup> party damage )  
 Operational       Others (including Mystery spills) \_\_\_\_\_

A SECTION OF 24" BOMU-BONNY PIPELINE AT KPOR SHOWING HACK SAW CUT AT 2 O' CLOCK POSITION

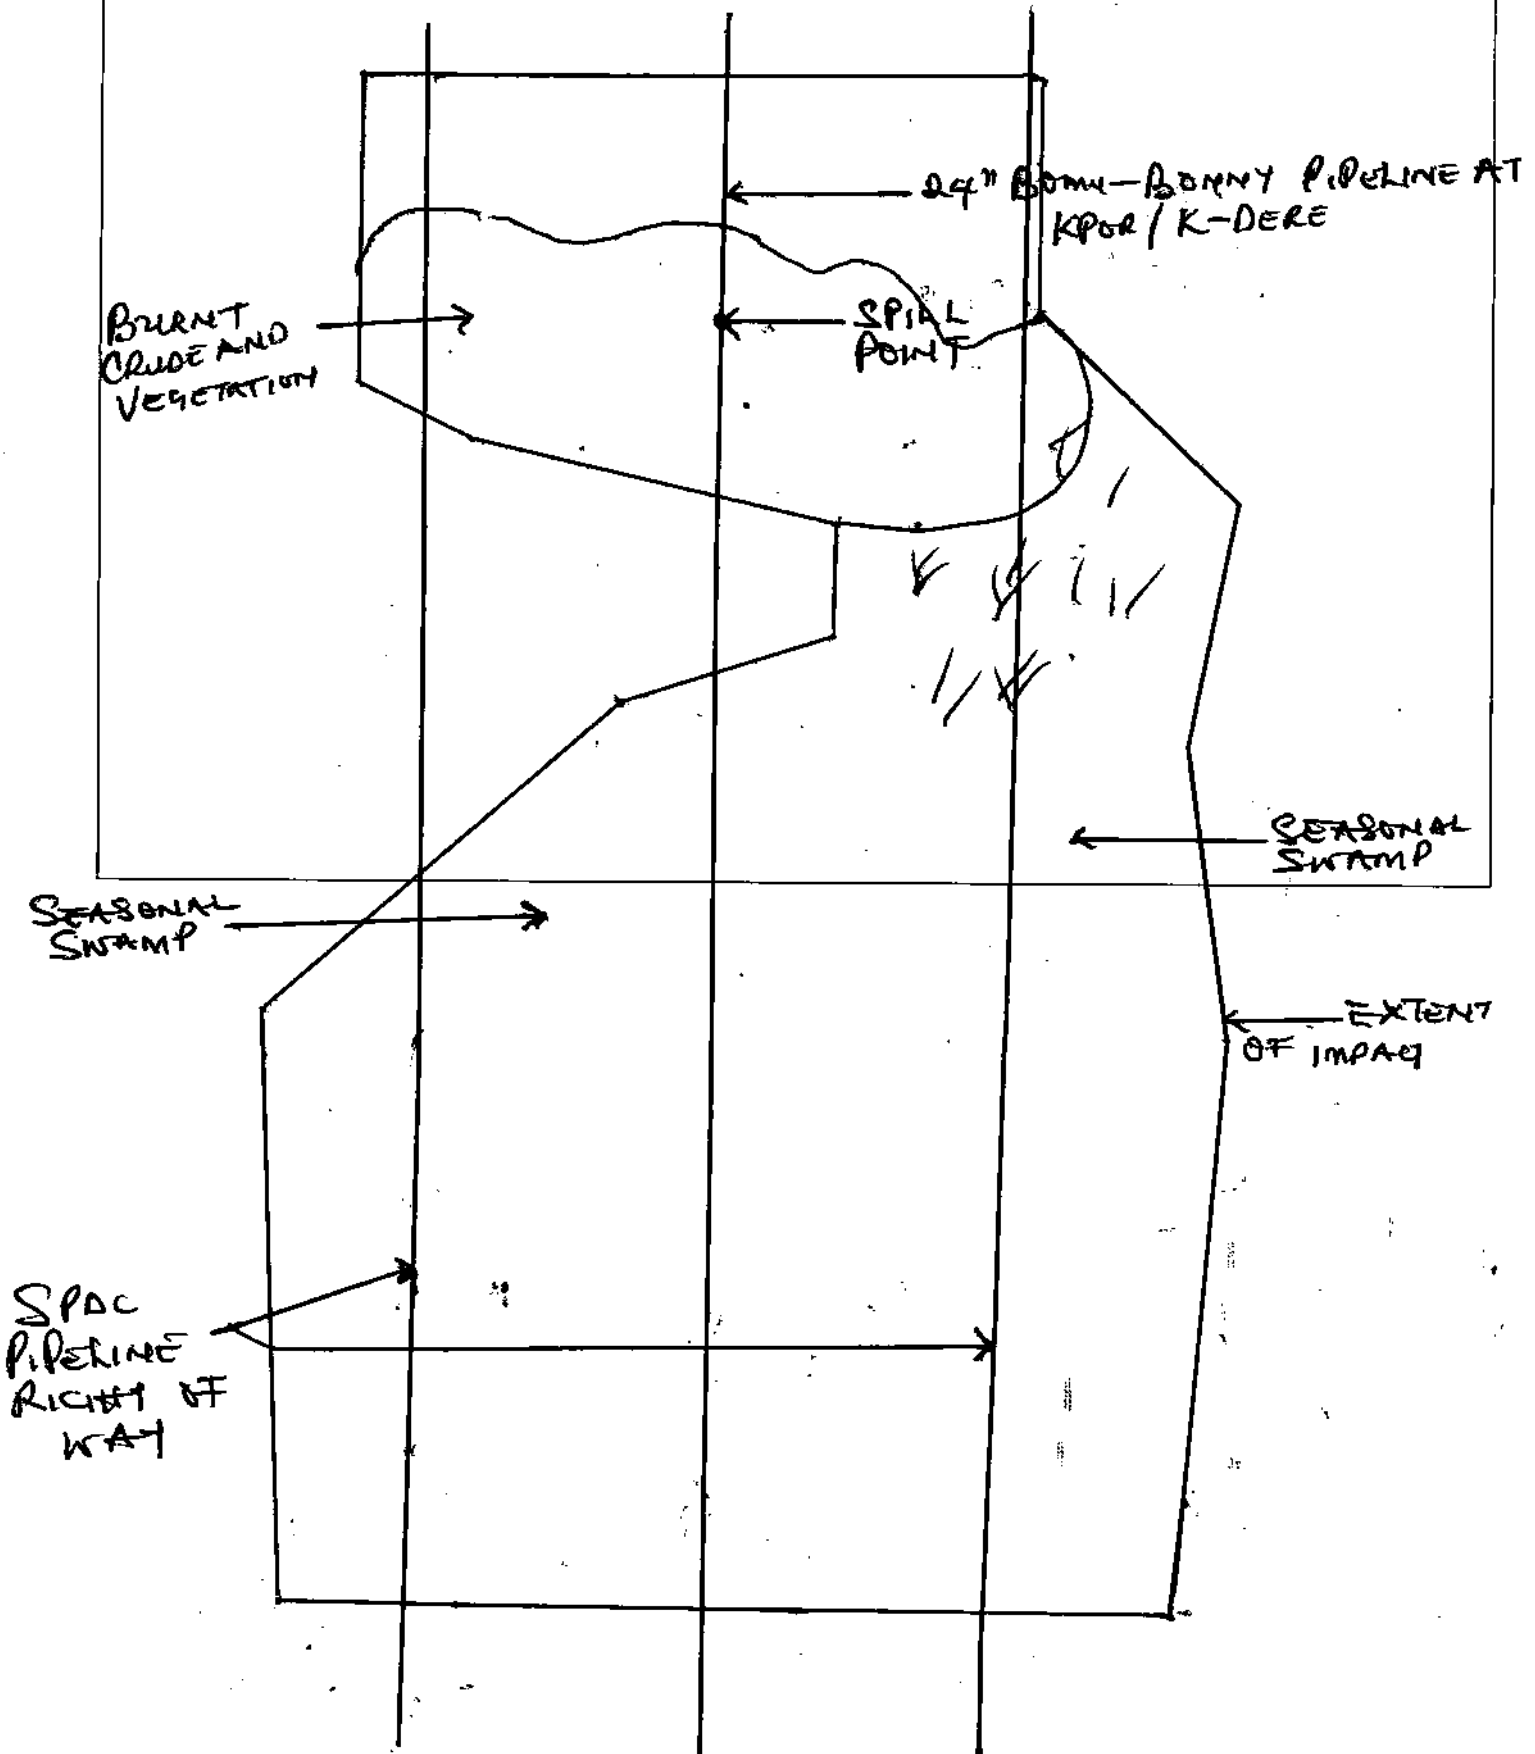
28. Appendix 1: Overview sketch of the site

24" BOMU-BONNY PIPELINE AT KPOR/K-DERE
