THE SHELL PETROLEUM DEVELOPMENT COMPANY OF NIGERIA LIMITED.

JOINT INVESTIGATION REPORT FOR INCIDENT NO: 1073523 JIV report S/N: 0350

1. Spill incident Number: 1073523 2. Type of incident* OIL SPILL
 3. Name of Location 14" OKORDIA - RUMUEKPE PIPELINE
 4. Name of nearest community IMOGU 5. State: RIVERS 6. LGA EMOHUA
 7. Type of Production facility/Installation OIL PIPELINE 8. Asset owner/District PIPELINE

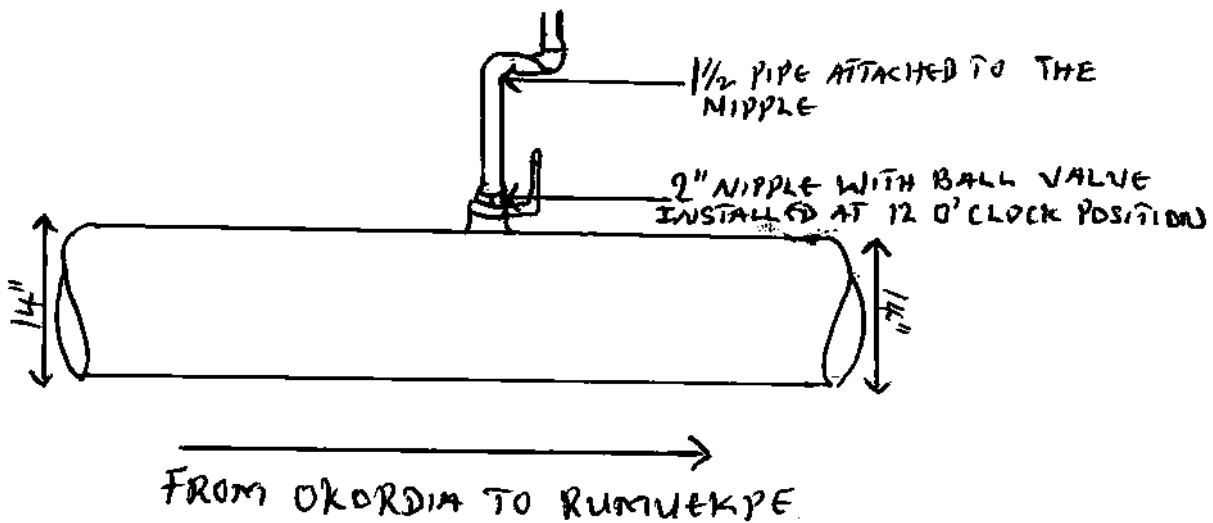
| <input checked="" type="checkbox"/> Failed Weld-on illegal hot tap valve, | <input type="checkbox"/> Failed Clamp | <input type="checkbox"/> Missing Pipeline/Flowline |
| <input checked="" type="checkbox"/> Crude oil theft (illegal bunkering) point, | | <input type="checkbox"/> Third party tampering with Clamp |

SECTION OF 14" OKORDIA - RUMUEKPE PIPELINE AT IMOBU SHOWING CRUDE OIL THEFT POINT INSTALLED AT 12 O'CLOCK POSITION.

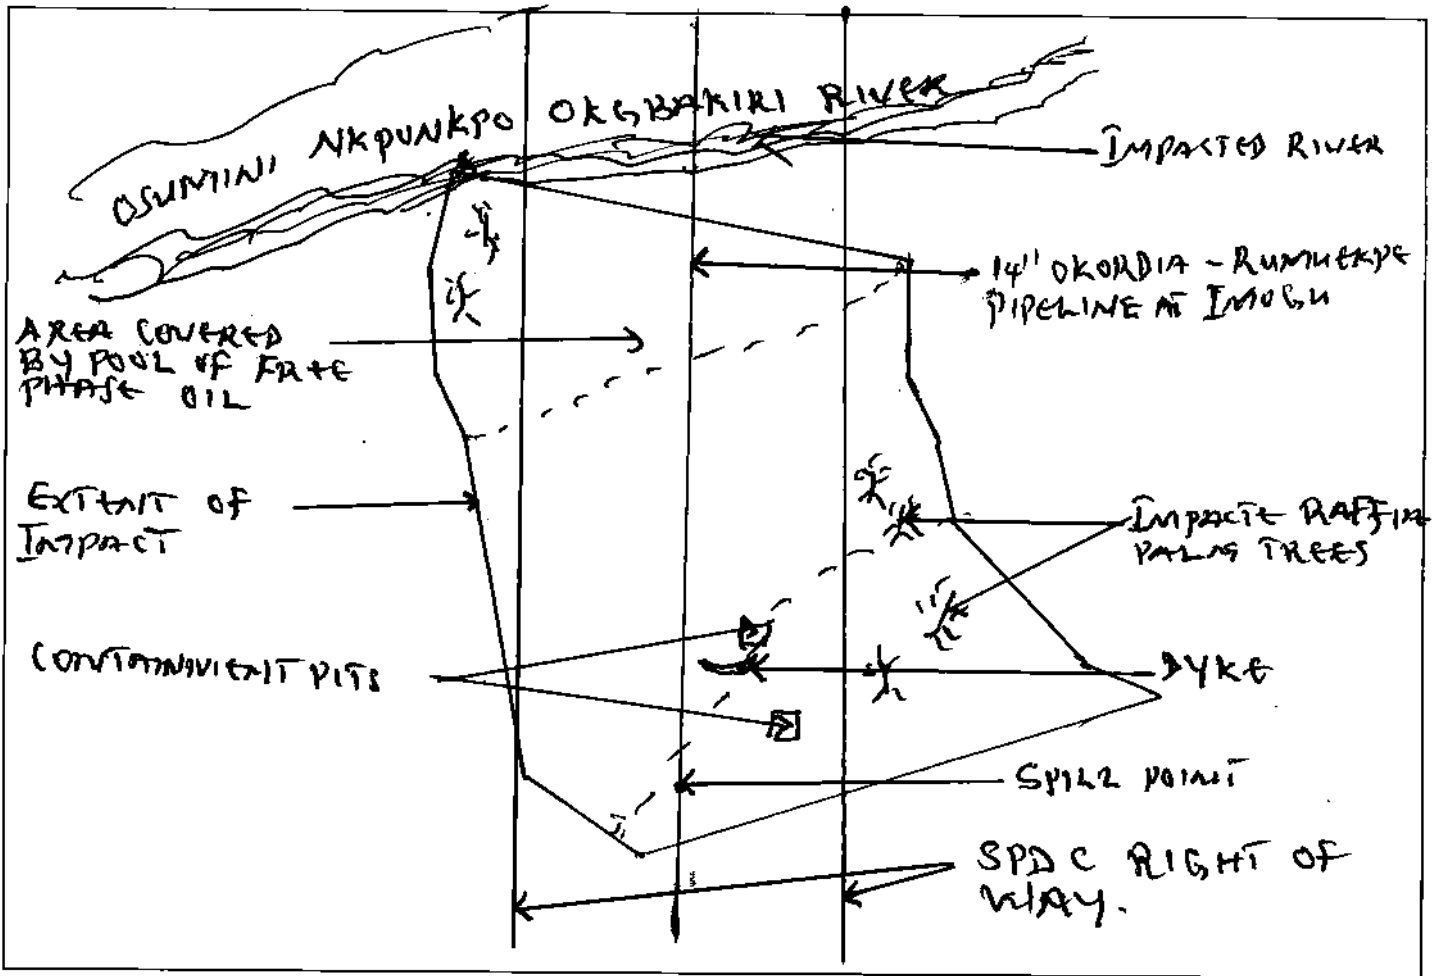
28. Appendix 1: Overview sketch of the site

Location: 14" OKORDIA - RUMUKEPE PIPELINE AT IMOGU
