THE SHELL PETROLEUM DEVELOPMENT COMPANY OF NIGERIA LIMITED.

JOINT INVESTIGATION REPORT FOR INCIDENT NO: 1280235 JIV report S/N: 00736

1. Spill incident Number: 1280235 2. Type of incident* OIL SPILL
 3. Name of Location 16" EGBEMA - ASSA TRANS NIGER PIPELINE
 4. Name of nearest community UMUDIKE 5. State: IMO 6. LGA OTTAJI - EGBEMA
 7. Type of Production facility/Installation OIL PIPELINE 8. Asset owner/District PIPELINE/LAND

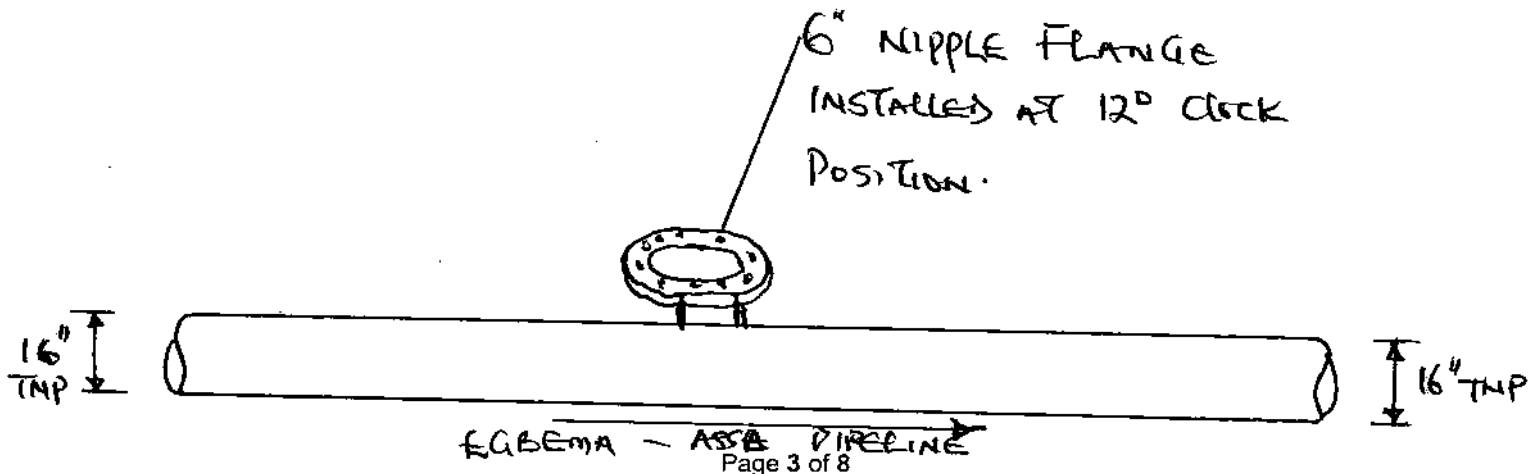
E. GRAPHIC DESCRIPTION OF LEAK POINT (while detail report of the leak point should be contained in the leak report, overview sketch of the site should be added as an appendix 1)

Additional observations around the spill point: THE JOINT INVESTIGATING TEAM OBSERVED SAND BAGS USED IN COVERING THEFT POINT.

| <input checked="" type="checkbox"/> Failed Weld-on illegal hot tap valve, | <input type="checkbox"/> Failed Clamp | <input type="checkbox"/> Missing Pipeline/Flowline |
| <input checked="" type="checkbox"/> Crude oil theft (illegal bunkering) point, | | <input type="checkbox"/> Third party tampering with Clamp |

SECTIONAL VIEW OF 16" EGBEMA - ASSA TRANS NIGER PIPELINE AT UMUDIKE SHOWING: FAILED WELD-ON ILLEGAL THEFT POINT.

If yes to item 14, give brief description: RECUVERY AND REPAIR WORK INITIATED AND COMPLETED.
