**THE SHELL PETROLEUM DEVELOPMENT COMPANY OF NIGERIA LIMITED.**

JOINT INVESTIGATION REPORT FOR INCIDENT NO: 1280683 JIV report S/N: 00762

1. Spill incident Number: 1280683 2. Type of incident: FIRE AND OIL SPILL  
 3. Name of Location: AKASO WELL 3 WELL HEAD  
 4. Name of nearest community: ILLOMATOKA 5. State: RIVERS 6. LGA: BONNY  
 7. Type of Production facility/Installation: WELL HEAD 8. Asset owner/District: SWAMP 1

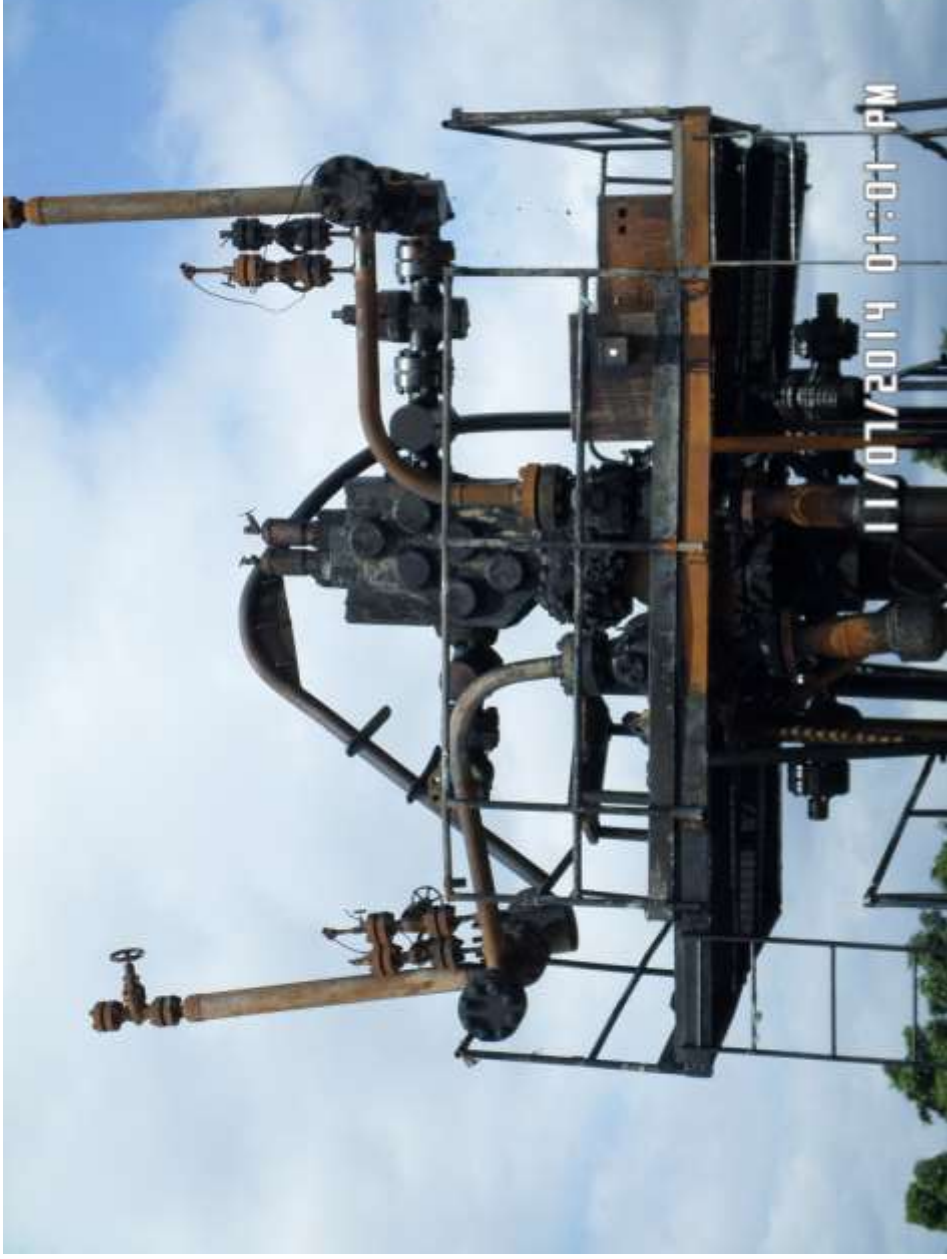
AKASO WELL3 WELLHEAD AT ILOMATURU

Additional observations around the spill point: THE WELL HEAD AND ITS SURROUNDINGS WERE BURNT BY FIRE. THE BEAN BOX, GATE VALVES AND KEROTEX VALVE ALL ON BOTH ARMS OF THE WELL HEAD WERE MISSING.

| <input type="checkbox"/> Relief valve failure | <input checked="" type="checkbox"/> Others (specify) <u>THE BEAN BOX, GATE VALVES AND KEROTEX VALVE ALL ON BOTH ARMS OF THE WELL HEAD WERE MISSING.</u> | |
