THE SHELL PETROLEUM DEVELOPMENT COMPANY OF NIGERIA LIMITED.

JOINT INVESTIGATION REPORT FOR INCIDENT NO: 1285765 JIV report S/N: 00764

1. Spill incident Number: 1285765 2. Type of incident* OIL SPILL
 3. Name of Location 12" IMO RIVER 2 - OGMLE PIPELINE
 4. Name of nearest community OWAZA 5. State: ABIA 6. LGA UKWA WEST
 7. Type of Production facility/Installation OIL PIPELINE 8. Asset owner/District PIPELINE

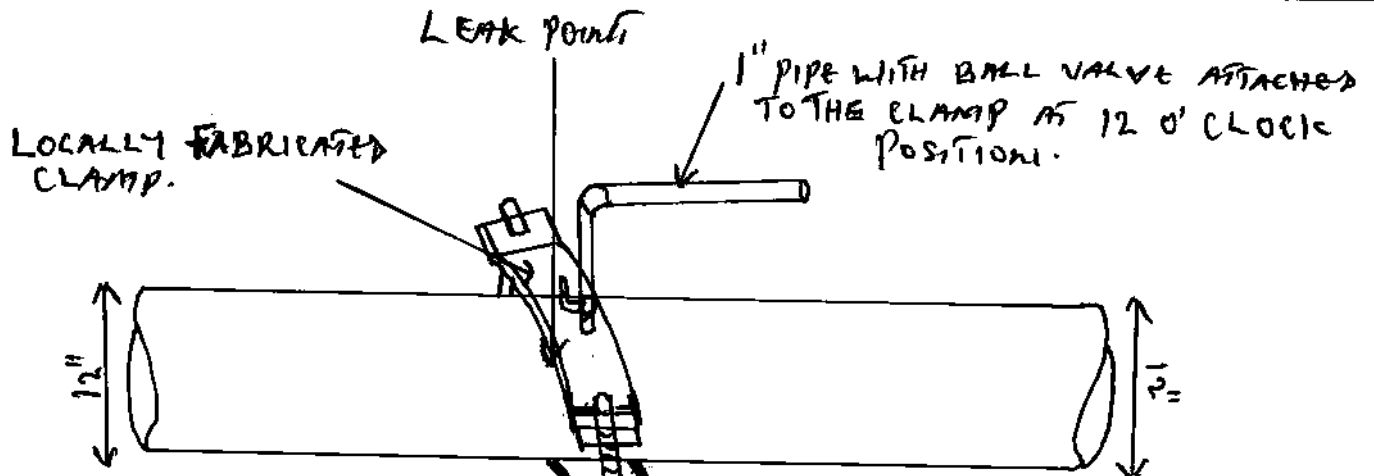
SECTION OF 12" IMO RIVER 2 - OGALÉ PIPELINE AT OHAZA SHOWING POSITION OF CRUDE OIL THREAT POINT AT 12 O'CLOCK.

← FROM IMO RIVER 2 TO OGALÉ.
