THE SHELL PETROLEUM DEVELOPMENT COMPANY OF NIGERIA LIMITED.

JOINT INVESTIGATION REPORT FOR INCIDENT NO: 1287218 JIV report S/N: 00749

1. Spill incident Number: 1287218 2. Type of incident* OIL SPILL
 3. Name of Location 4" AHIA WELL 3S FLOWLINE
 4. Name of nearest community EGBEDA 5. State: RIVERS 6. LGA EMOHUA
 7. Type of Production facility/Installation FLOWLINE 8. Asset owner/District LAND 2

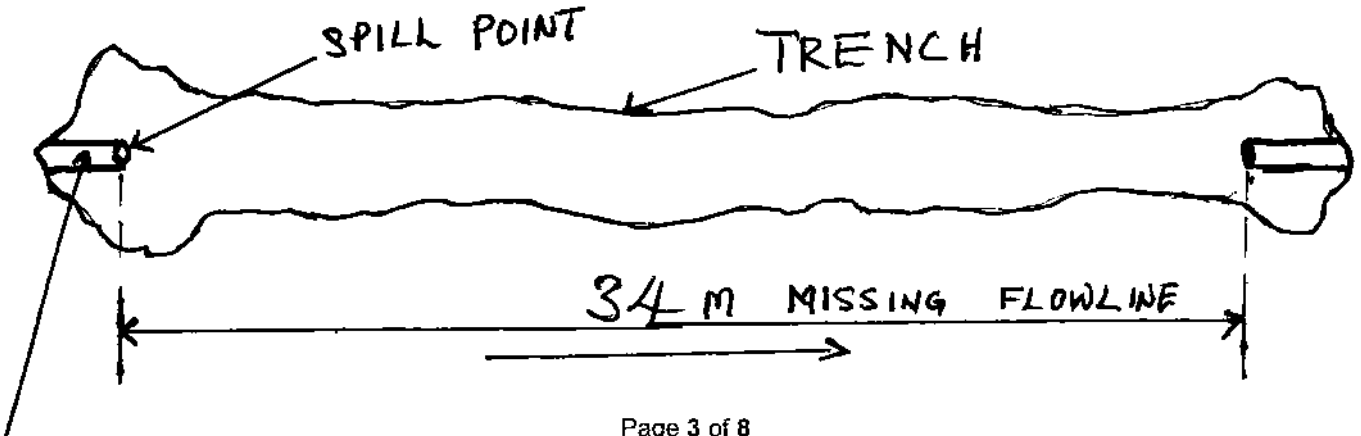
Additional observations around the spill point: THE IMPACTED AREA WAS MEASURED WITH TAPE ON SITE DURING J.I.V. THE JOINT INVESTIGATION TEAM ALSO OBSERVED A MISSING SECTION OF THE FLOWLINE

A SECTION OF 4" AHIA WELL 3S FLOWLINE SHOWING 34 METERS MISSING FLOWLINE AT EGBEDA.
