THE SHELL PETROLEUM DEVELOPMENT COMPANY OF NIGERIA LIMITED.

JOINT INVESTIGATION REPORT FOR INCIDENT NO: 1292543 JIV report S/N: 00778

1. Spill incident Number: 1292543 2. Type of incident* OIL SPILL
 3. Name of Location 28" NKPOH-BOMU PIPELINE
 4. Name of nearest community ELELENWO 5. State: RIVERS 6. LGA OBIO/AKPO
 7. Type of Production facility/Installation OIL PIPELINE 8. Asset owner/District PIPELINE

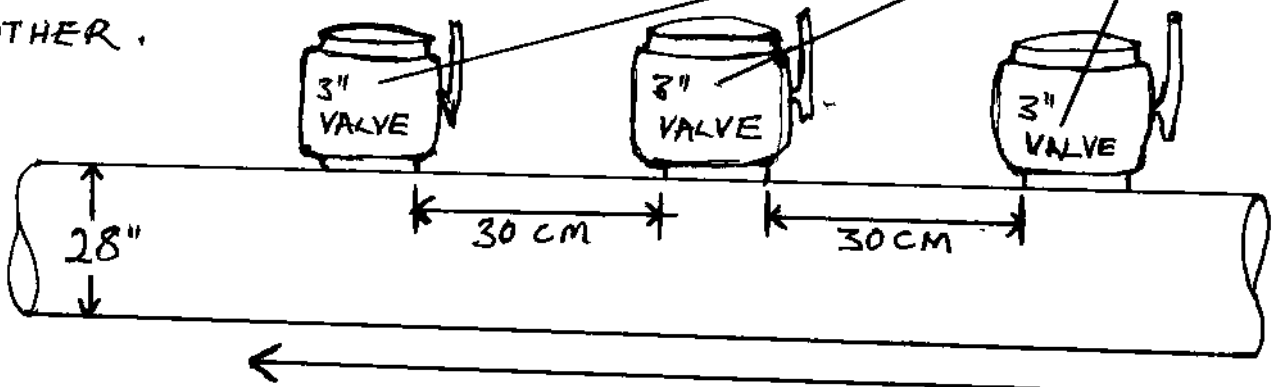
3" VALVES/
SPILL POINTS

Additional observations around the spill point: THE JOINT INVESTIGATION TEAM OBSERVED 3 NOS OF 3" VALVES INSTALLED 30CM FROM EACH, AT 12 O'CLOCK POSITIONS.

| <input checked="" type="checkbox"/> Crude oil theft (illegal bunkering) point, | | <input type="checkbox"/> Third party tampering with Clamp |

A SECTION OF 28" NKPOKU - BOMU PIPELINE AT ELELENUO SHOWING 3 NO OF 3" VALVES INSTALLED AT 12 O'CLOCK, POSITIONS AND 30 CENTI METER FROM EACH OTHER.

THE MAINTENANCE TEAM COMMENCED REPAIR AFTER JOINT INVESTIGATION.
