THE SHELL PETROLEUM DEVELOPMENT COMPANY OF NIGERIA LIMITED.

JOINT INVESTIGATION REPORT FOR INCIDENT NO: 1285806 JIV report S/N: 00769

1. Spill incident Number: 1285806 2. Type of incident* OIL SPILL
 3. Name of Location AMIA WELL 3S AND WELL 3L PIPELINE FLOWLINES
 4. Name of nearest community EGBEDA 5. State: RIVERS 6. LGA EMOTHUA
 7. Type of Production facility/Installation OIL FLOWLINE 8. Asset owner/District LAND 2

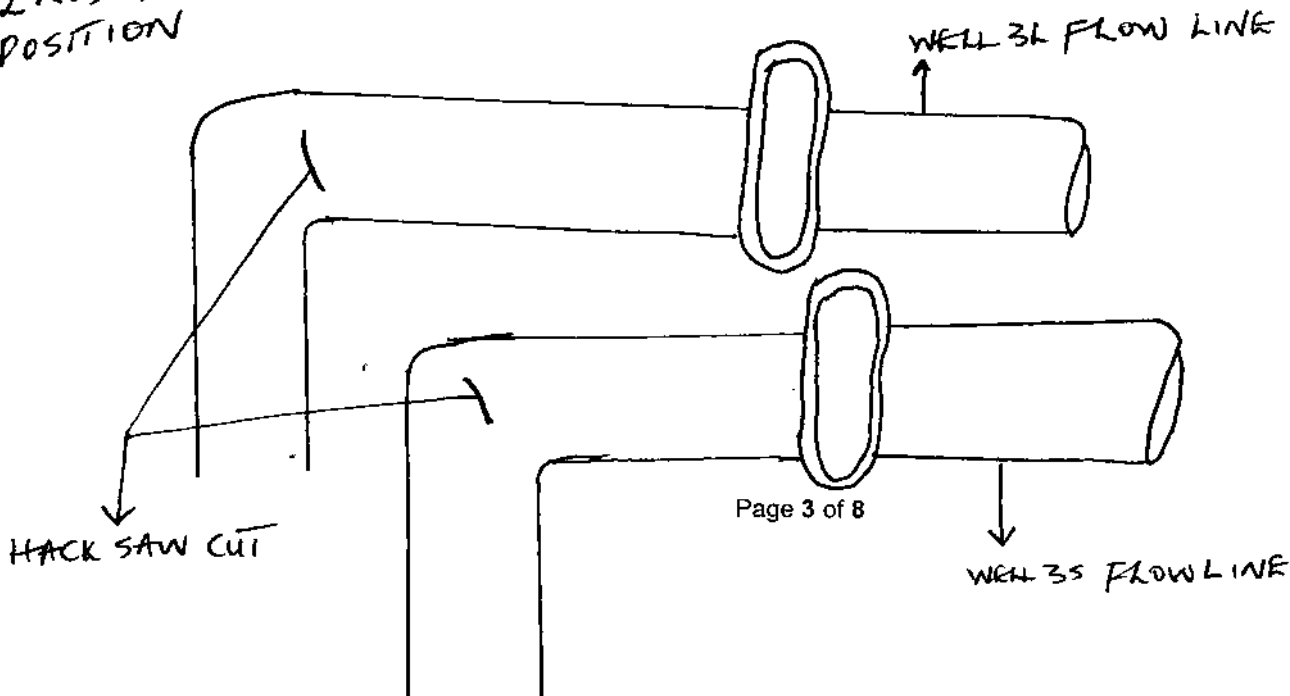
| <input type="checkbox"/> Drilled hole | <input checked="" type="checkbox"/> Hack saw cut | <input type="checkbox"/> Tear (_____), |

- Third party interference (Sabotage , crude theft ; Line theft ; Accidental 3rd party damage
 Operational Others (including Mystery spills) _____

SECTION OF AHIA WELL 35 AND WELL 3L FLOWLINES AT EGBEDA SHOWING 2 NOS HACKSAW CUT AT ~~ONE~~ CLOCK POSITION

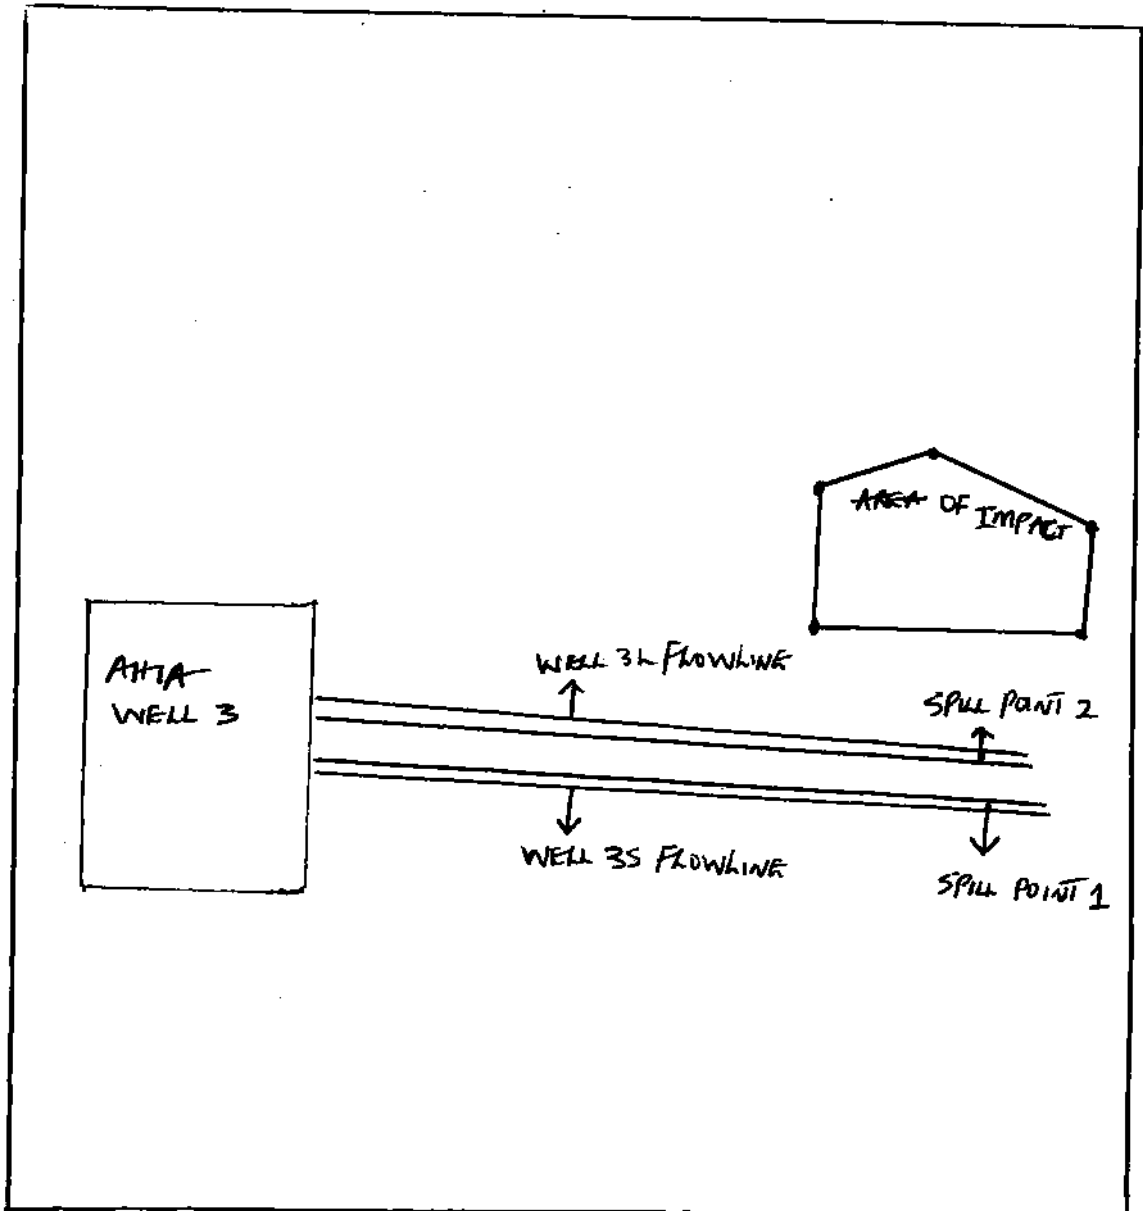
25. Appendix 1: Overview sketch of the site

Location: AHIA WELL 3S AND WELL 3L FLOWLINES AT EGBEDA
