THE SHELL PETROLEUM DEVELOPMENT COMPANY OF NIGERIA LIMITED.

JOINT INVESTIGATION REPORT FOR INCIDENT NO: 1288358 JIV report S/N: 00786

1. Spill incident Number: 1288358 2. Type of incident* OIL SPILL
 3. Name of Location 28" BOMU - BONNY PIPELINE
 4. Name of nearest community MOGHO 5. State: RIVERS 6. LGA GOKANA
 7. Type of Production facility/Installation OIL PIPELINE 8. Asset owner/District PIPELINE

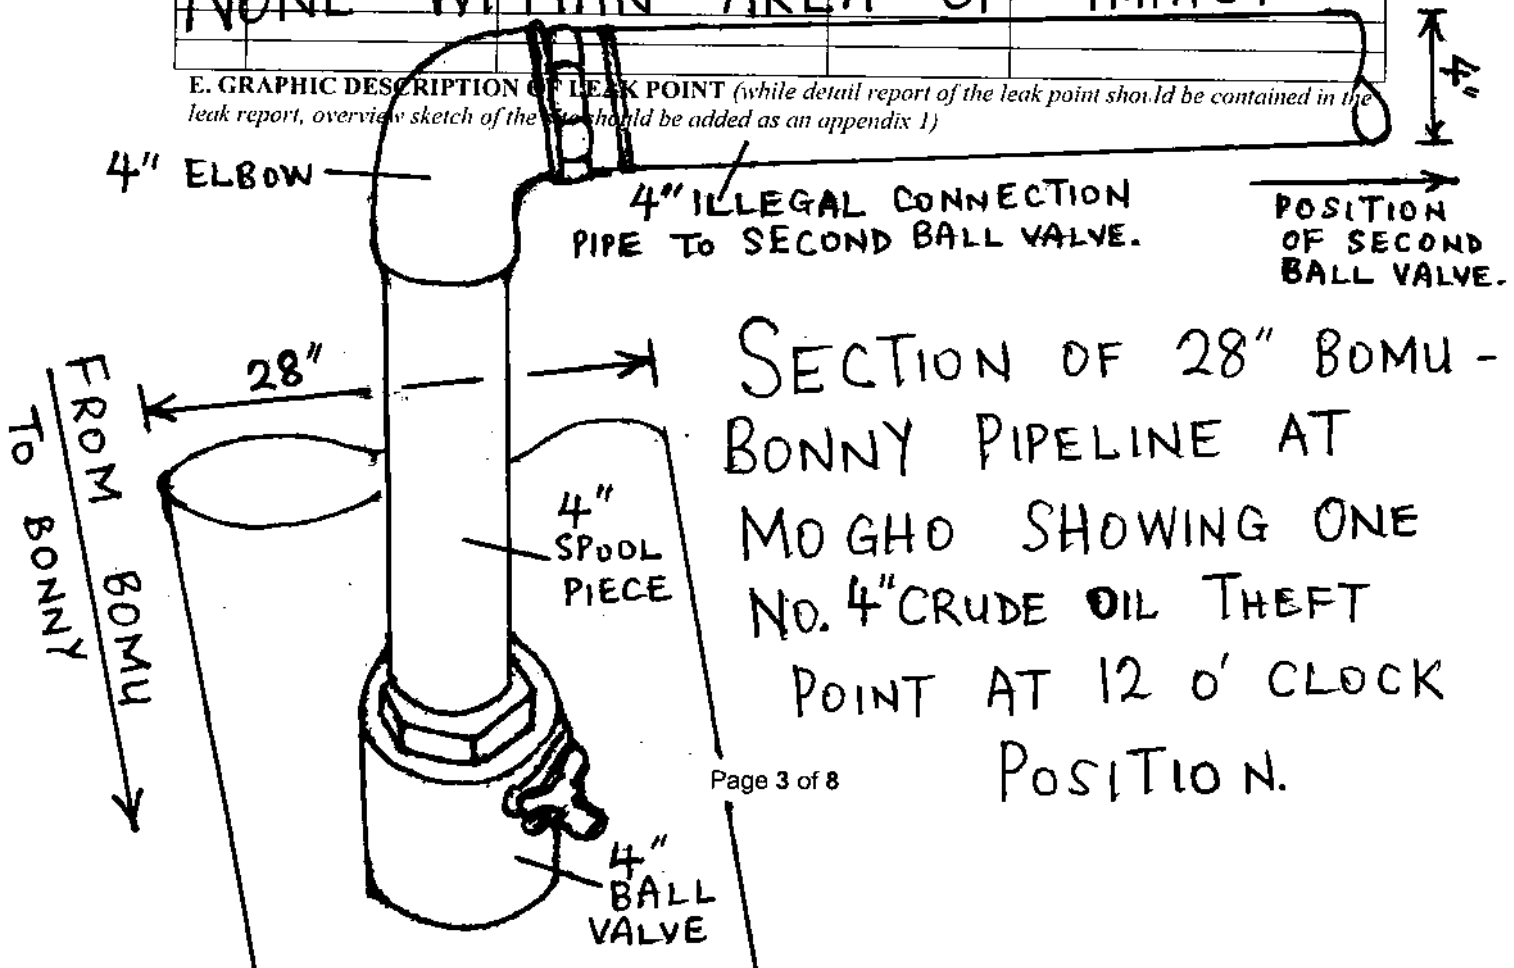
E. GRAPHIC DESCRIPTION OF LEAK POINT (while detail report of the leak point should be contained in the leak report, overview sketch of the site should be added as an appendix 1)

| <input checked="" type="checkbox"/> Failed Weld-on illegal hot tap valve, | <input type="checkbox"/> Failed Clamp | <input type="checkbox"/> Missing Pipeline/Flowline |
| <input checked="" type="checkbox"/> Crude oil theft (illegal bunkering) point, | | <input type="checkbox"/> Third party tampering with Clamp |

RECOVERY OF FREE-PHASE OIL WAS DONE WHILE TEMPORARY REPAIRS WERE CARRIED OUT ON THE AFFECTED PIPELINE SECTION BY SCREW CAPPING THE CRUDE THEFT POINT VALVE AND DISCONNECTING THE VALVE HANDLE.
