JOINT INVESTIGATION REPORT

INCIDENT NO: 1479299 JIV report S/N: Nº 0000049

1. Spill incident Number: 1479299 2. Type of incident* OIL SPILL/FIRE
3. Name of Location 28" NKPKU - BOMU PIPELINE
4. Name of nearest community NORKPO 5. State: RIVERS 6. LGA TAI
7. Type of Production facility/Installation OIL PIPELINE
8. Asset owner/District THE SHELL PETROLEUM DEVELOPMENT COMPANY OF NIGERIA (SPDC)

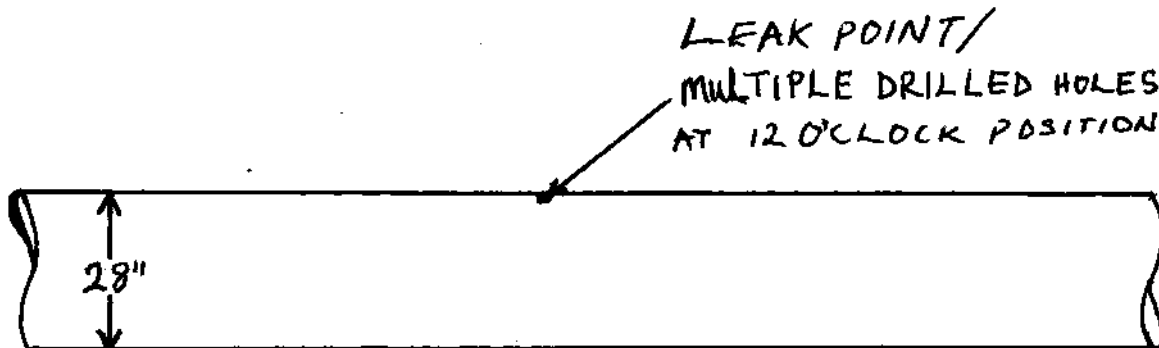
| <input checked="" type="checkbox"/> Drilled hole | <input type="checkbox"/> Hack saw cut | <input type="checkbox"/> Tear (_____) |

E. GRAPHIC DESCRIPTION OF LEAK POINT (while detail report of the leak point should be contained in the leak report, overview sketch of the site should be added as an appendix 1) A SECTION OF 28" NKPOKU - BOMU PIPELINE AT NORKPO SHOWING DRILLED HOLES AT 12 O'CLOCK POSITION, DONE BY UNKNOWN PERSON(S)

LEAK STOPPED, AND REPAIR COMMENCED
